9th National Conference of the Hellenic Society of Non Destructive Testing Nov 11th, Athens

NDT prospection in the study, implementation and monitoring of the rehabilitation of the Holy Aedicule of the Holy Sepulchre in Jerusalem within the Scientific integrated governance

Materials & Conservation, Reinforcement and Rehabilitation Interventions in the Holy Aedicule of the Holy Sepulchre

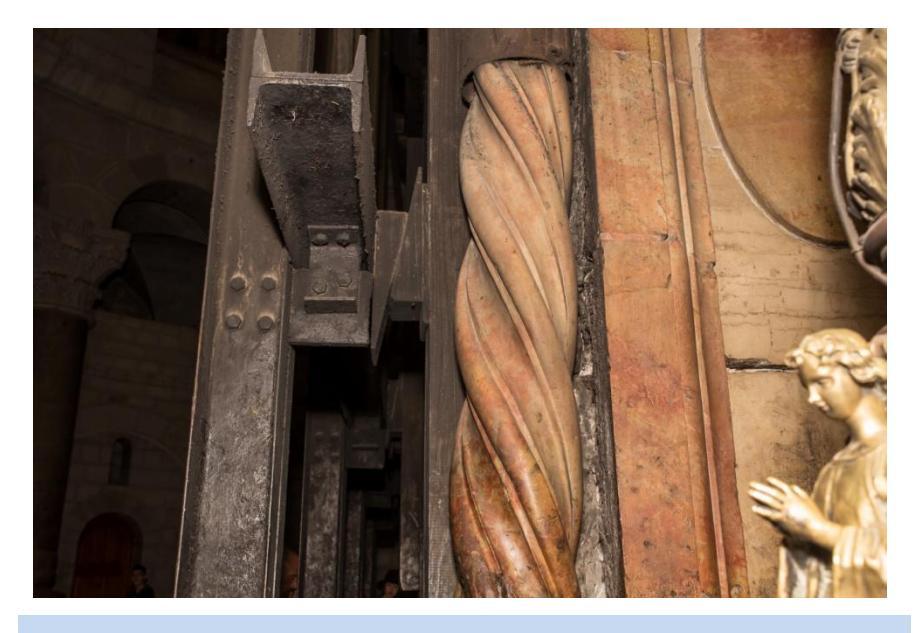
The cause of the deformation is the deterioration of the mortars. Swelling of the masonry:

☆A historic cause of the swelling was the water precipitation through the open oculus of the dome above the Aedicule, until 1870

*Thereafter, as investigated by NTUA, the main source of humidity is the uptake through capillary rise from the surrounding water canals and underground voids.

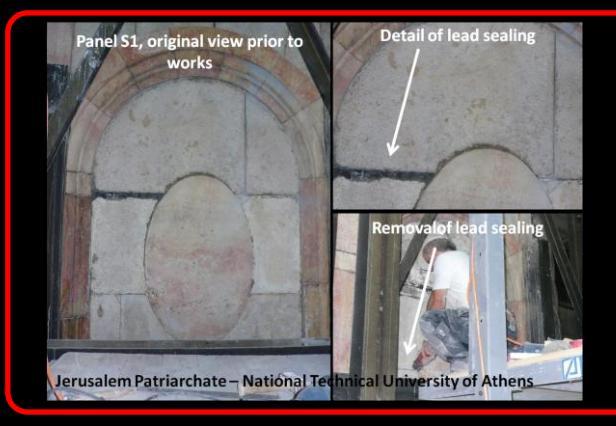
The joint of the slabs comprising the stone panels surrounding the Holy Aedicule were sealed by Komnenos with the use of lead, a technique dating to stone buildings of antiquity, but which created severe problems in the specific structure, leading to moisture concentration within the masonry. The lead present in the joints had to be removed, in order to dismantle and remove the slabs of the panels

Prior to the removal of each slab of the panel, supports were designed and constructed in order to ensure the stability of the remaining panels

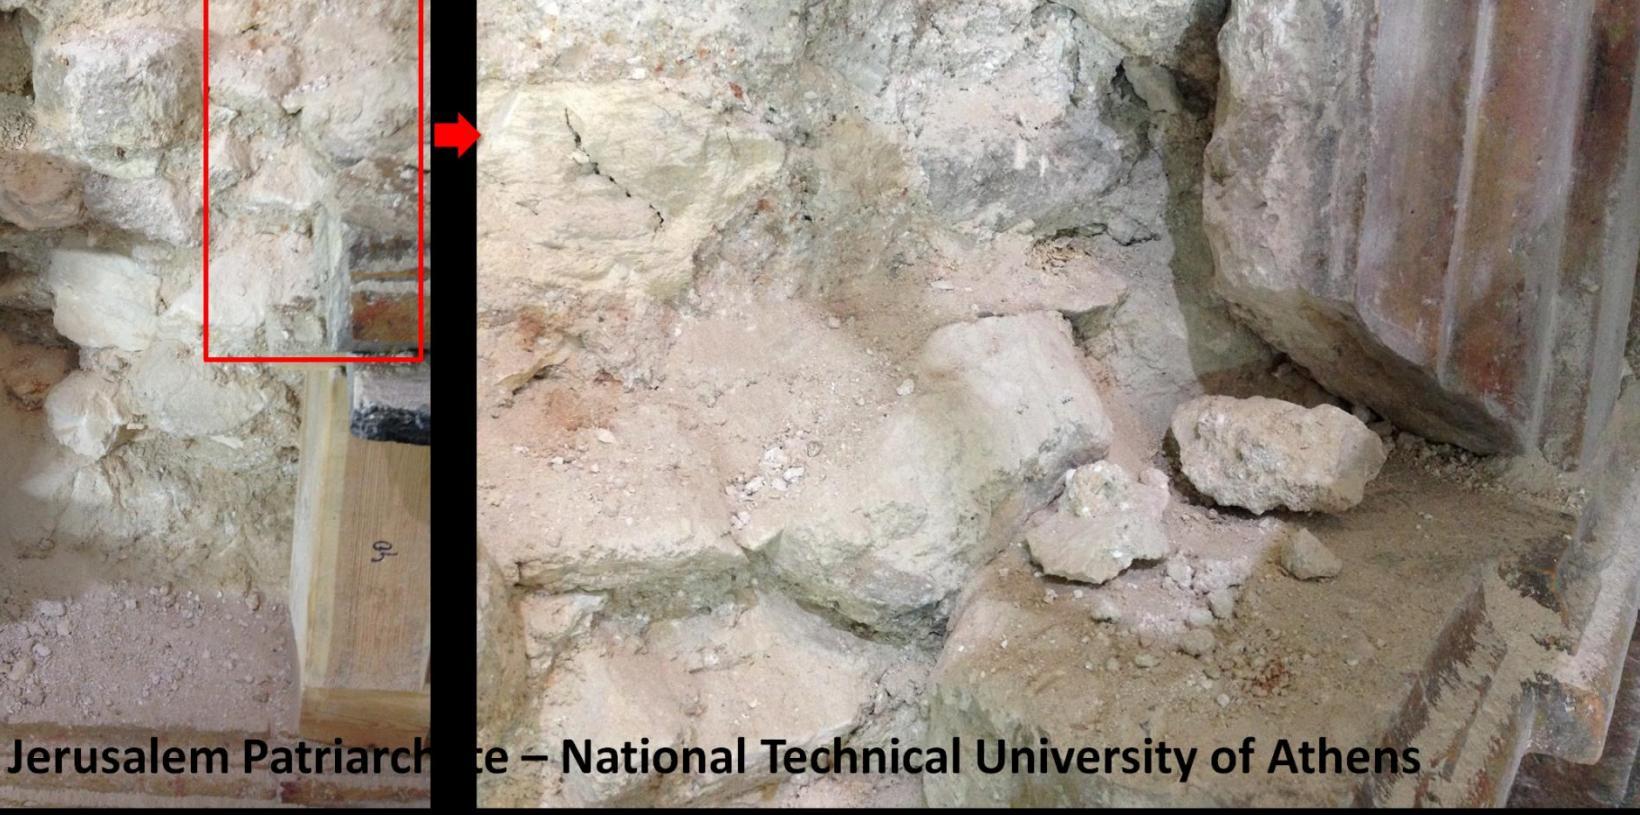
The filling mortar, applied by Komnenos between the stone slabs and the masonry, was found highly disintegrated at the removal of the panels; the rain water entering from the roof caused the mortar to lose coherence and therefore it no further served the purpose it was intended to, having also lost adherence to the masonry and the stone slabs

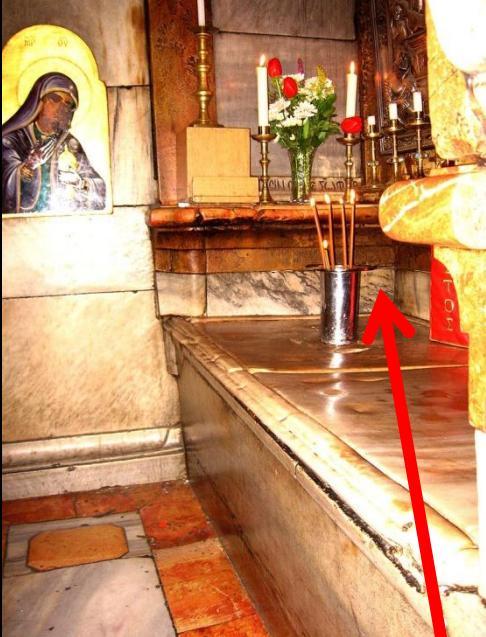
When removing the disintegrated masonry in N5, the northwest corner of the tomb was revealed, thus verifying the NTUA Study regarding the Holy Rock boundaries

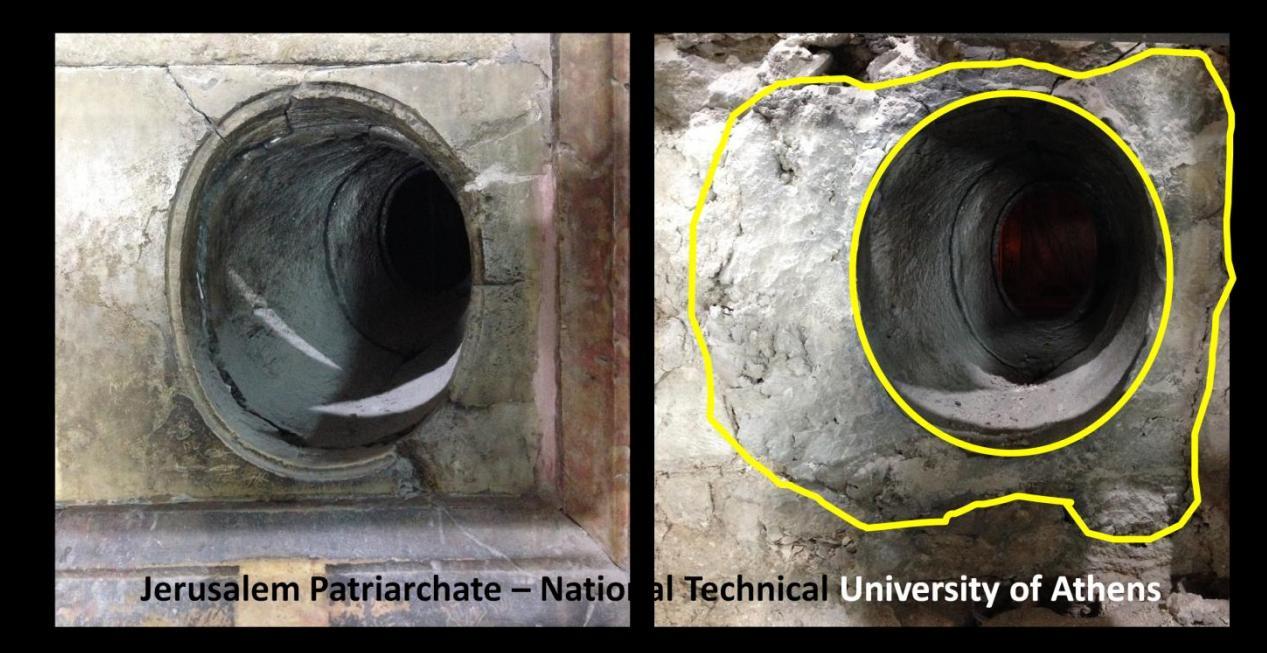
Use of incompatible materials in nondocumented recent restorations: The removal of the stone slabs around the opening in N1, revealed the use of Portlant cement (area between the yellow curves)

The use of incompatible mortars, such as cement, in addition to multiple other issues it arises, does not allow for the necessary "respiration" of the masonry due to its incompatible microstructure, thus resulting in the aggravation of the masonry swelling.

Therefore, at this point it was deemed essential to **remove all incompatible materials** of the bad undocumented modern interventions, in order to ensure that the degradation processes they enhance and even in some cases provoke are stopped.

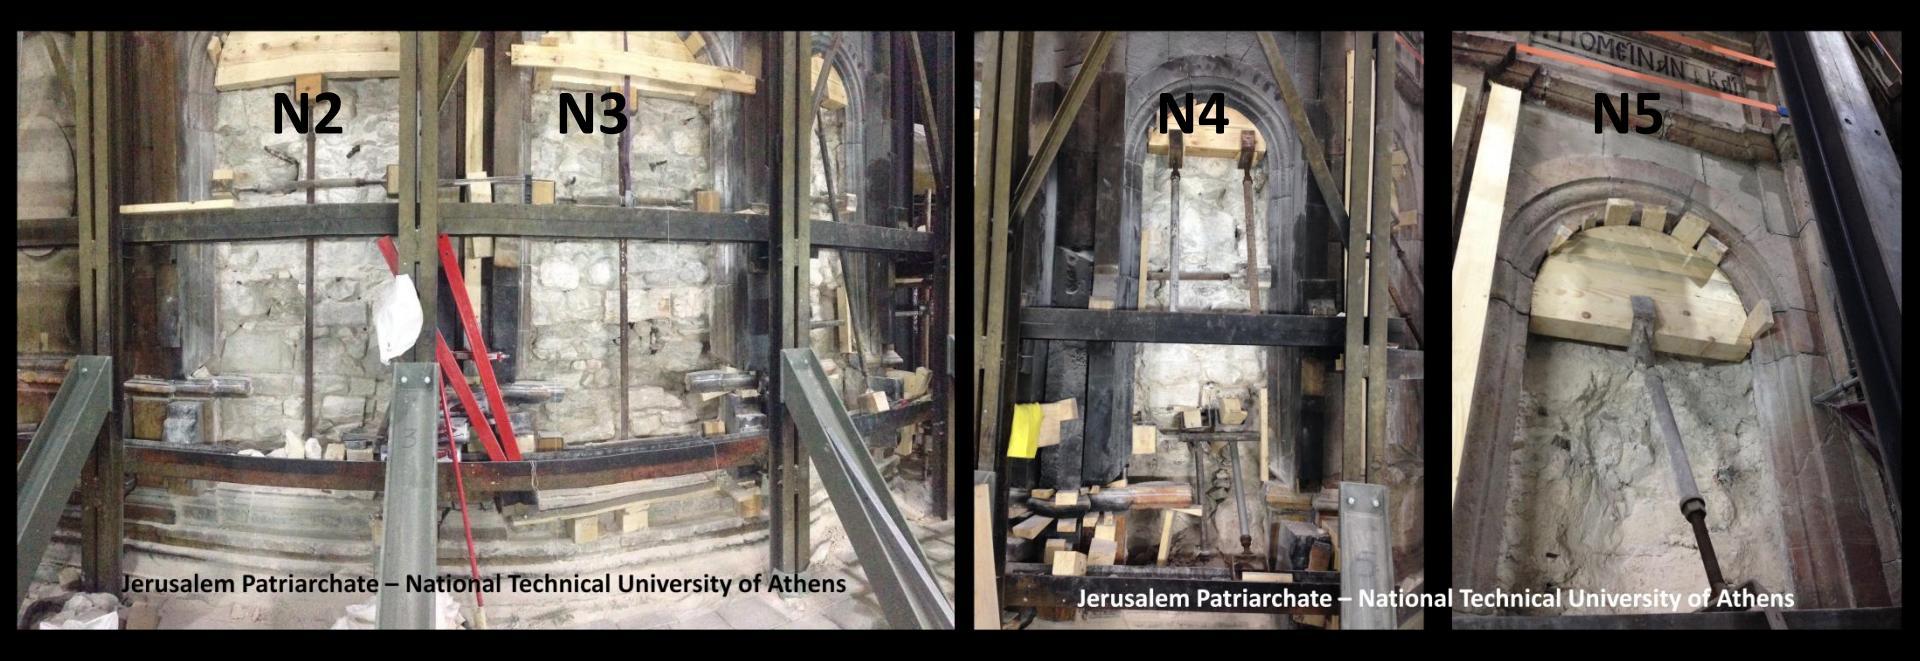
The masonries revealed after the removal of the Komnenos filling mortar further verified the conclusions of the NTUA study and were in need of repair

The masonry joint mortars appear disintegrated and the masonry appears swollen in its lower part, however <u>the degree of mortar disintegration was found different on</u> <u>the masonry behind each slab</u>.

The masonry revealed behind slabs in areas <u>N2, N3</u>, after the removal of the highly disintegrated outer layer of mortar, was <u>in a relatively good state of preservation</u>, the masonry behind slabs in area <u>N4</u> was found in a <u>moderate state</u> of preservation, however, the masonry behind slabs in area <u>N5</u> was found in an <u>extremely bad state</u> of preservation

The internal masonry layers become a focal point for the decision making concerning repairs, others being intact and others degrading, and need to be reconstructed

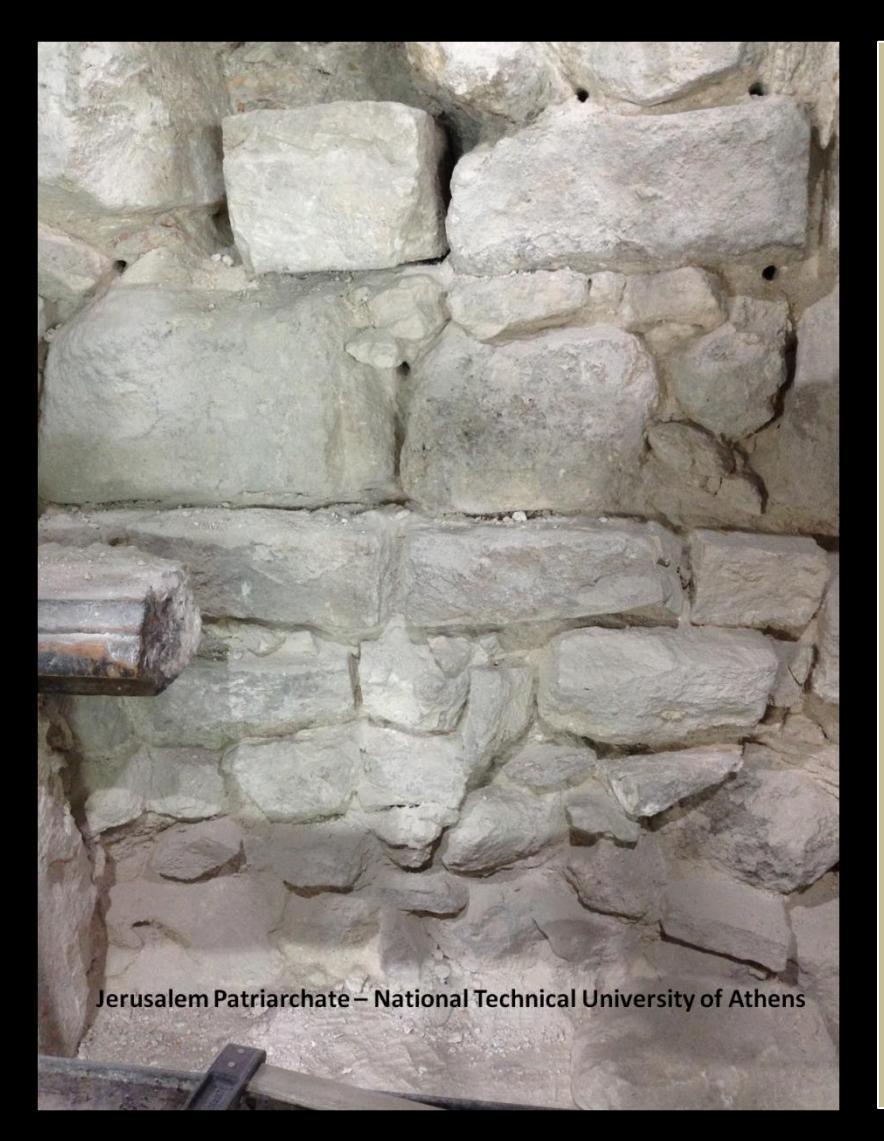
Effect of the irregular shape of stones on the masonry's strength

Regarding the mechanism of observed deformation of the structure - at its lower level - which is most possibly attributed to the mortars used, and taking into account that the masonry is generally built of irregular shaped stones, it should be noted that <u>EVEN THE WORST QUALITY MORTARS</u> <u>CANNOT BE RESPONSIBLE FOR ANY</u> <u>DEFORMATION DUE TO VERTICAL LOADS, IF</u> <u>THE STONES ARE HEALTHY WITH NARROW</u> <u>HORIZONTAL JOINTS</u>.

Behind certain slabs it is obvious, especially up to a height of four feet from the wall base, that <u>ALL STONES ARE COMPLETELY</u> <u>IRREGULAR WITH STRONGLY INCLINED</u> <u>JOINTS</u>. Furthermore, many of the stones in this area, have suffered extensive decay

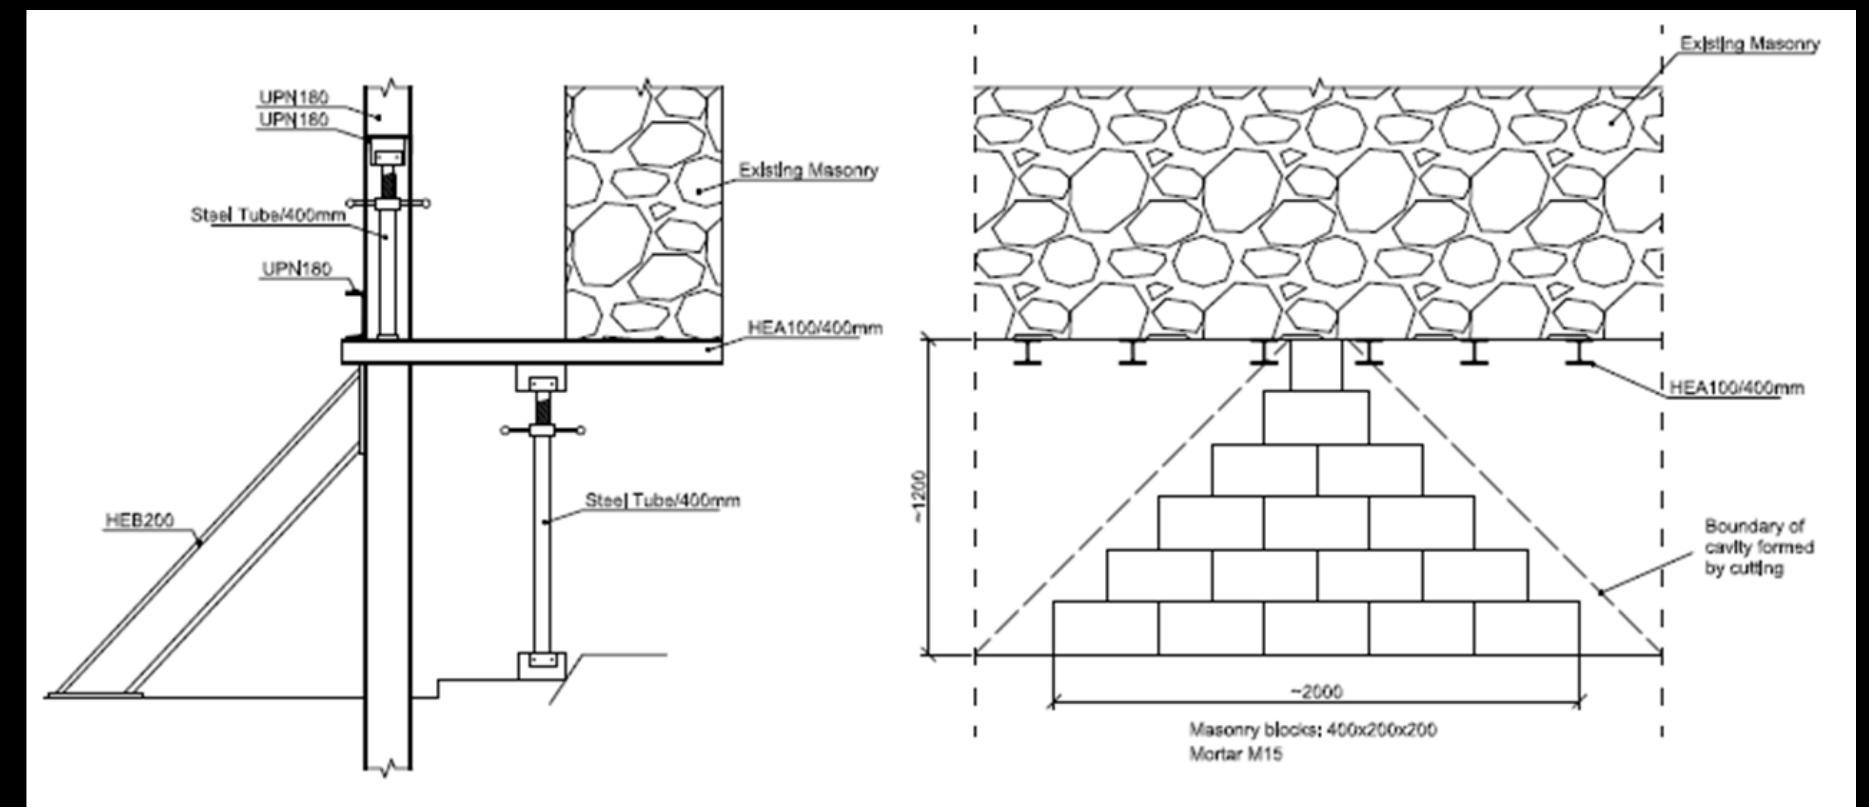
Preliminary designs of the retaining system that will be used for the construction of the new wall (designs by Assist. Prof. Ch. Mouzakis, Deputy Construction Site Manager)

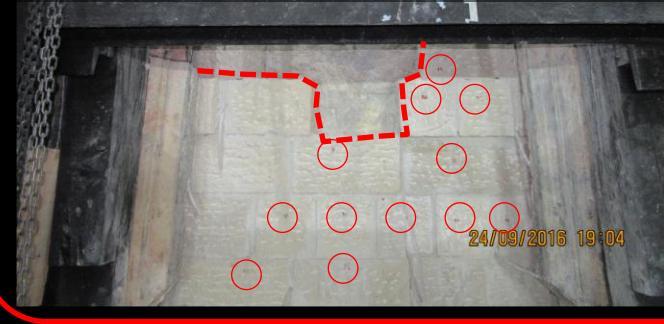
Jerusalem Patriarchate – National Technical University of Athens Example of reconstructed masonry (S3) conforming to the shape of the Holy Rock. Number indicate the depth from the surface of the new masonry at which the Holy Rock has been identified

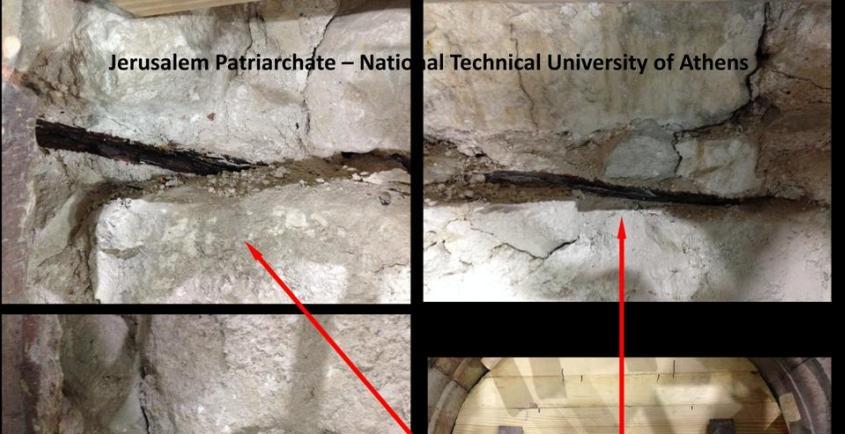
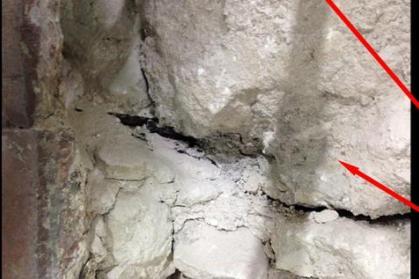
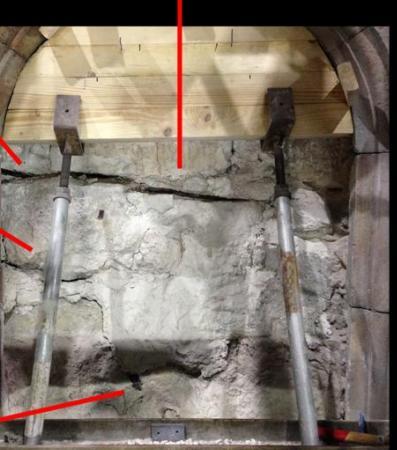
Corroded iron support bars

Fully corroded iron support bars in area N1

The removal of the stone slabs, as well as the removal of the disintegrated layer of mortar between the slabs and the masonry, revealed the <u>FULL CORROSION</u> <u>OF THE IRON SUPPORT BARS</u>, which were used to support large stone slabs (e.g, the oval slabs) or embedded within the masonry, connecting external and internal layers.

The corrosion of these iron bars <u>NECESSITATES THEIR COMPLETE</u> <u>REMOVAL, ACCOMPANIED WITH</u> <u>STRENGTHENING (E.G. REBUILDING,</u> <u>GROUTING) OF THE RESULTANT EMPTY</u> <u>SPACE CREATED BY THEIR REMOVAL</u>

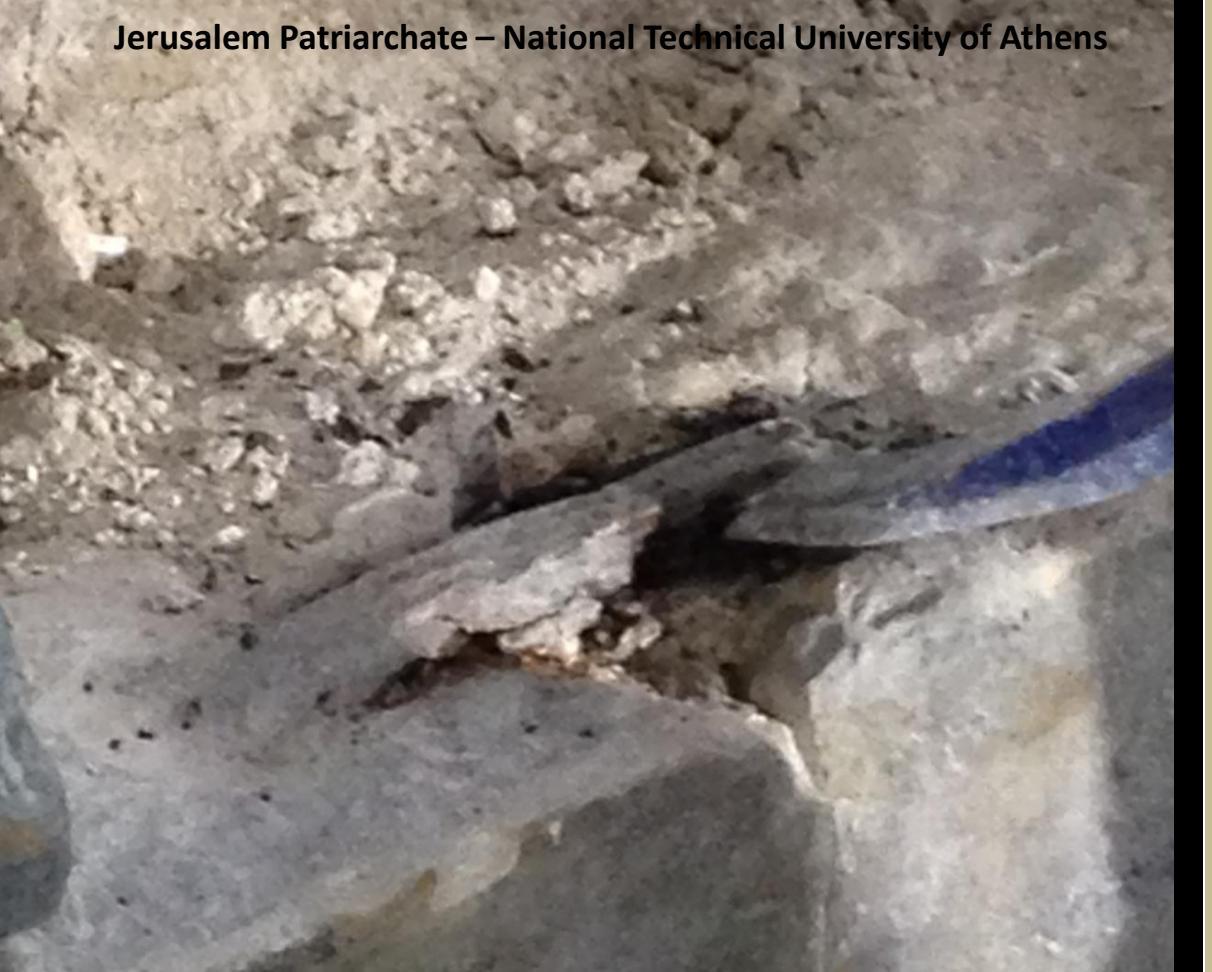
Iron connectors between stone slabs for the stabilization of the panels

During the removal of stone slabs, it was evident that <u>THE</u> <u>IRON CONNECTORS</u> between stone slabs that function as stabilization of the panels were corroded too.

- If the metallic element is in a parallel position in relation to the masonry surface and in a depth up to 7 centimeters, the use of corrosion inhibitors via spray application are considered as the optimum technique.

- If the metallic element is in a vertical position in relation to the masonry surface or in a parallel position but in a depth greater than 7 centimeters, it is advisable to use corrosion inhibitor "cartridges".

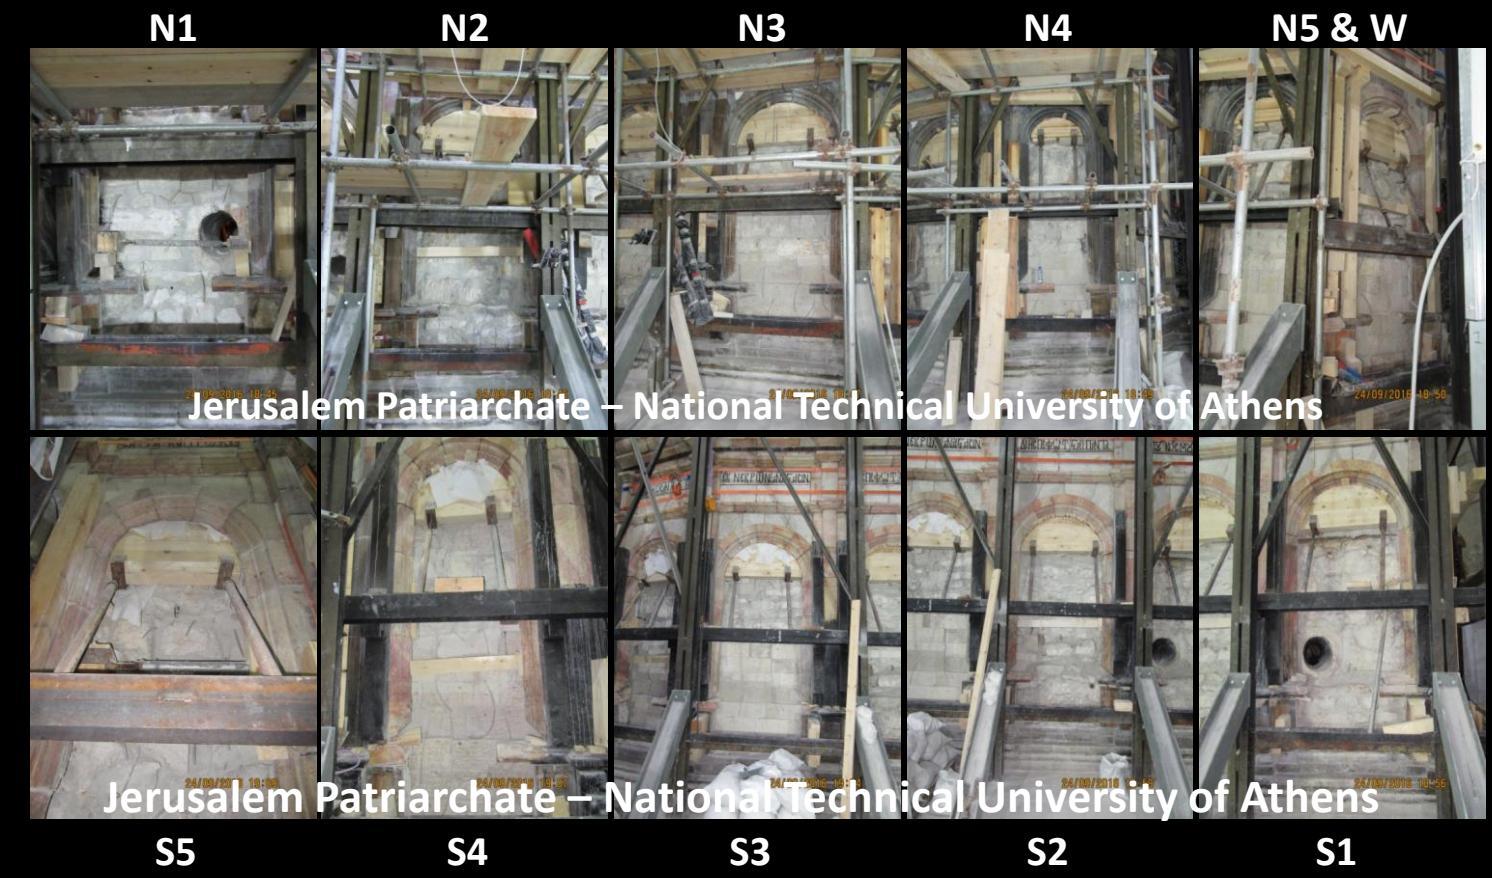
It is necessary to have all panels removed at the time of the injection, in order to control and manage the grouting procedure. The revealed masonries must be cleaned of disintegrated mortars and repointing must be complete. Injections pipes must be installed, creating a clear matrix at different depths (in a depth sequence of 1/3, 1/2 and 2/3 of the masonry thickness). THE ABOVE HAVE BEEN ACCOMPLISHED. Injection pipes have also been applied in the cracks and openings of the surface of the Holy Rock.

Masonries ready for grout injections

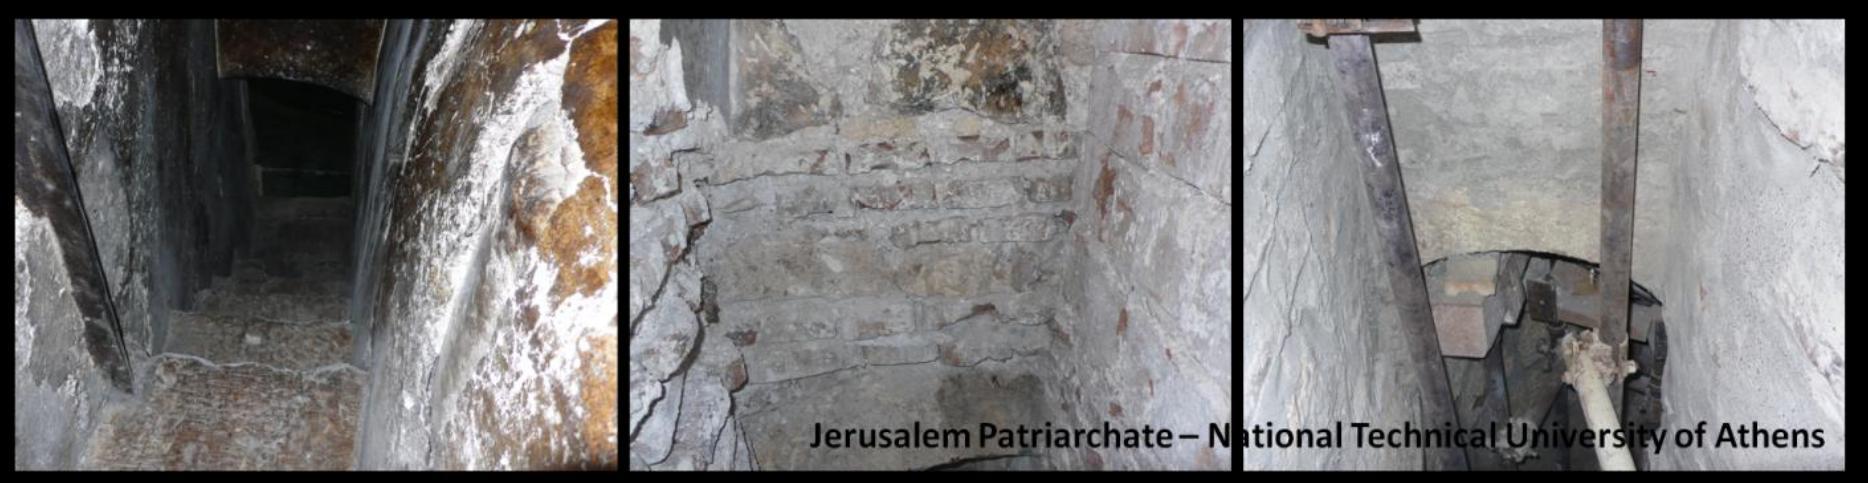
DUE TO THE BAD STATE OF PRESERVATION OF THE PLASTERS AND JOINT MORTARS AT THE STAIRCASE AREAS (north and south staircases), there was a risk that, during the grouting process, grout would preferentially flow through cracks from the plaster surfaces into the staircases space, as well as flow into the interface between the staircase masonry and the staircase plaster, <u>"flaking out" the plaster layer</u>.

Sequence of interventions on the staircases so far: (left) condition prior to interventions, (middle) after removal of the plaster and disintegrated mortars, (right) after repointing. South staircase (left and middle images), north staircase (right image)

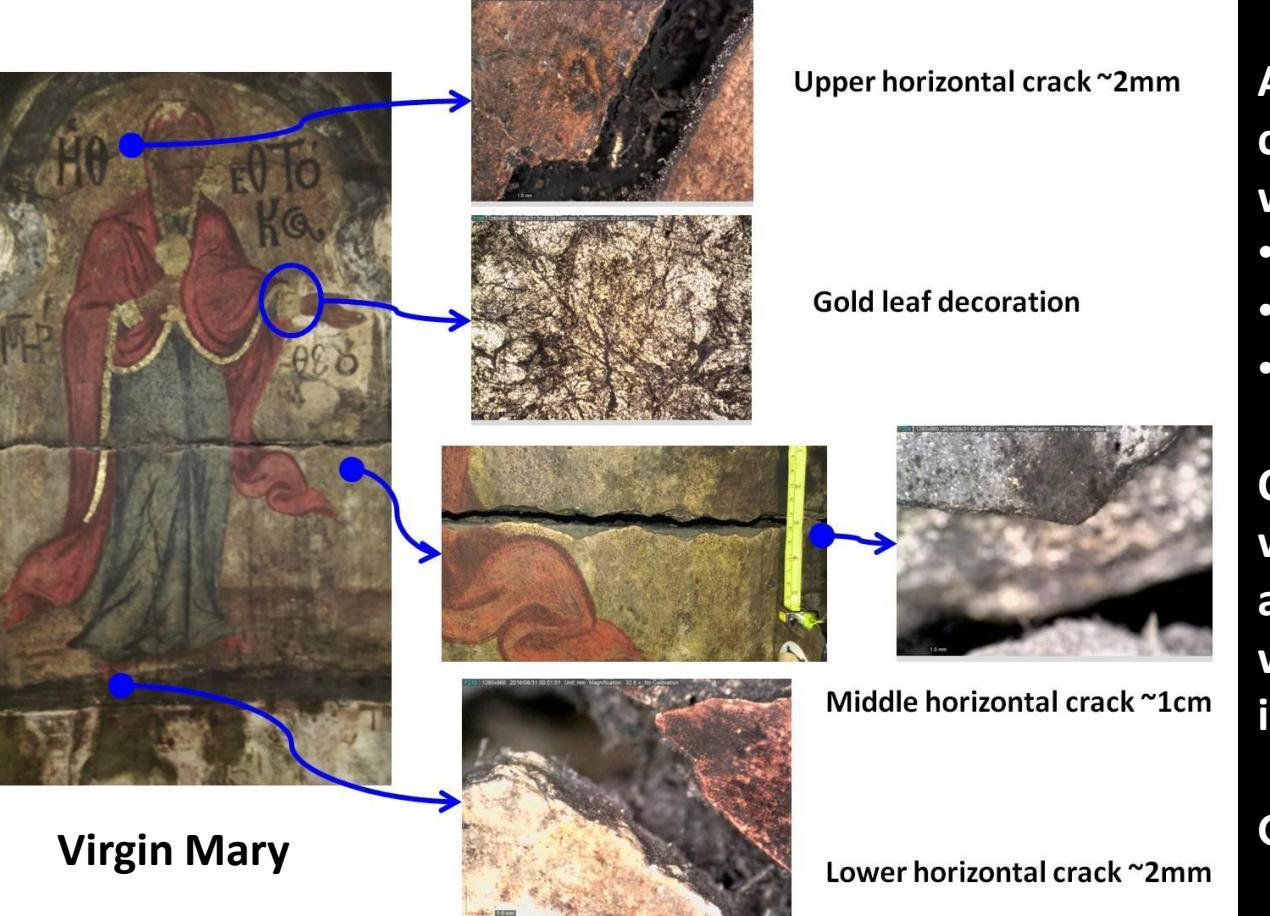
Aesthetical & physicochemical degradation of the wall painting due to: •Black soot particles •dust fall and •black depositions

Cracks of several and different widths (from capillary size to almost of one centimeter width) can be visually inspected.

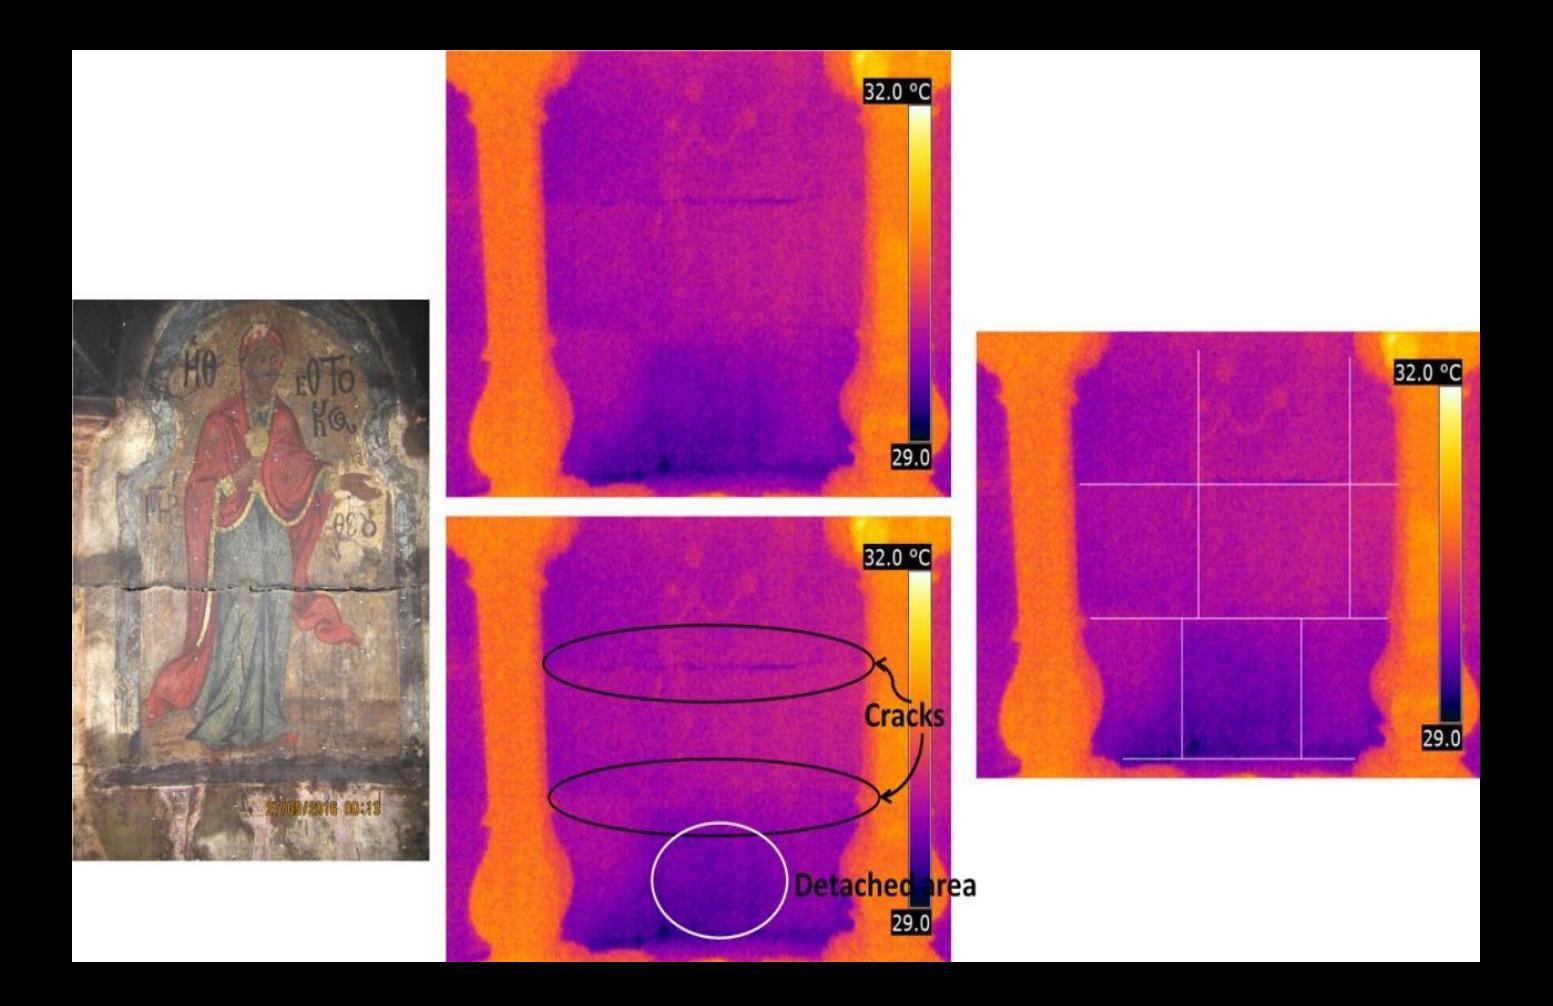
IRT investigation of Mary Virgin (north) demonstrating detached areas, cracks & joints of the underneath structure

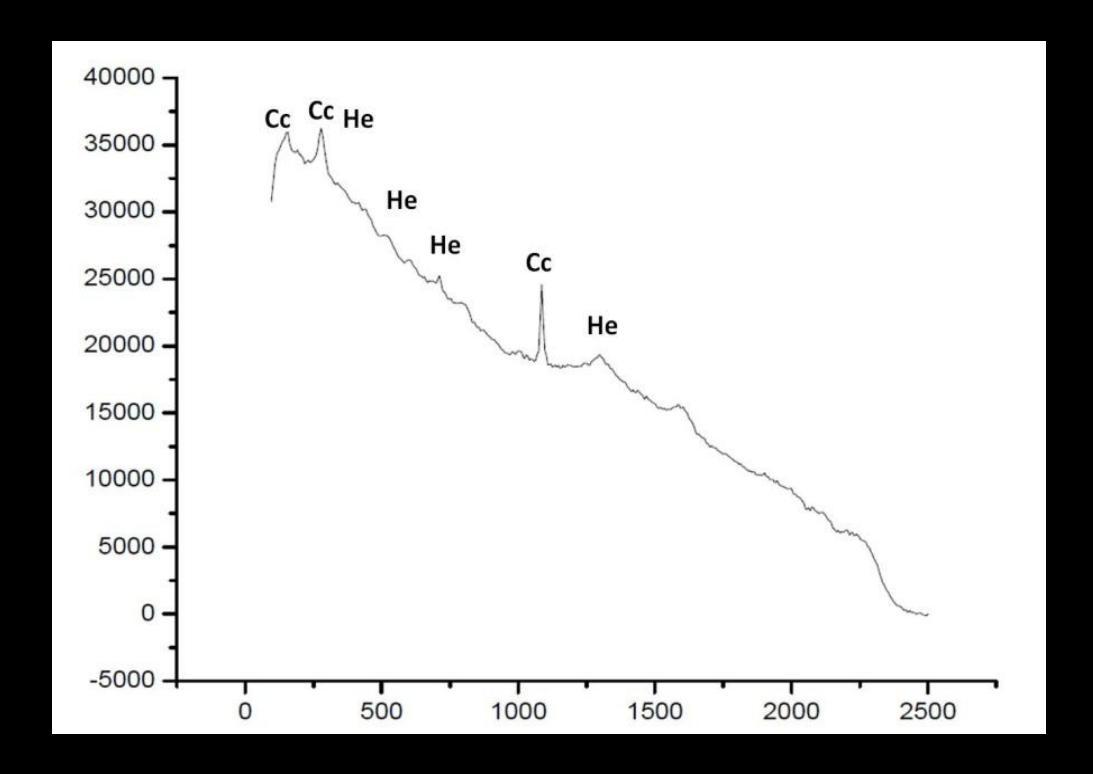
Preliminary Raman Spectroscopy results demonstrate the possible use of mineral pigments, since peaks of calcite and hematite are identified (investigated area of reddish hue).

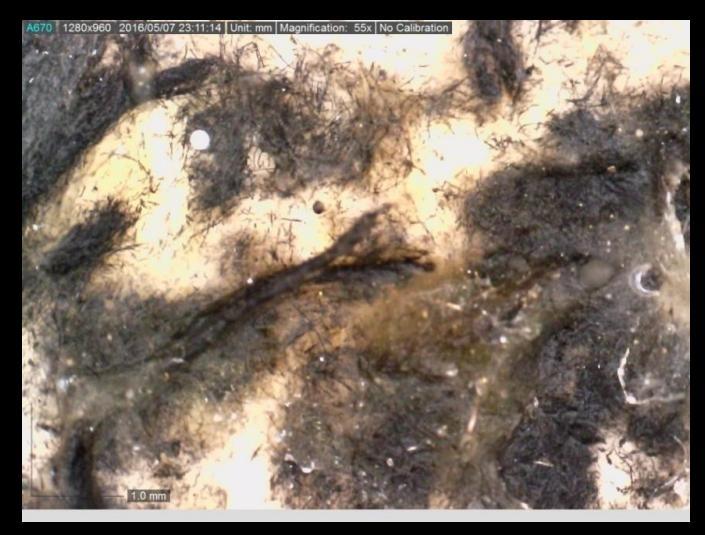
FOM image of mizzy stone surface of the South façade, presenting black & oily depositions

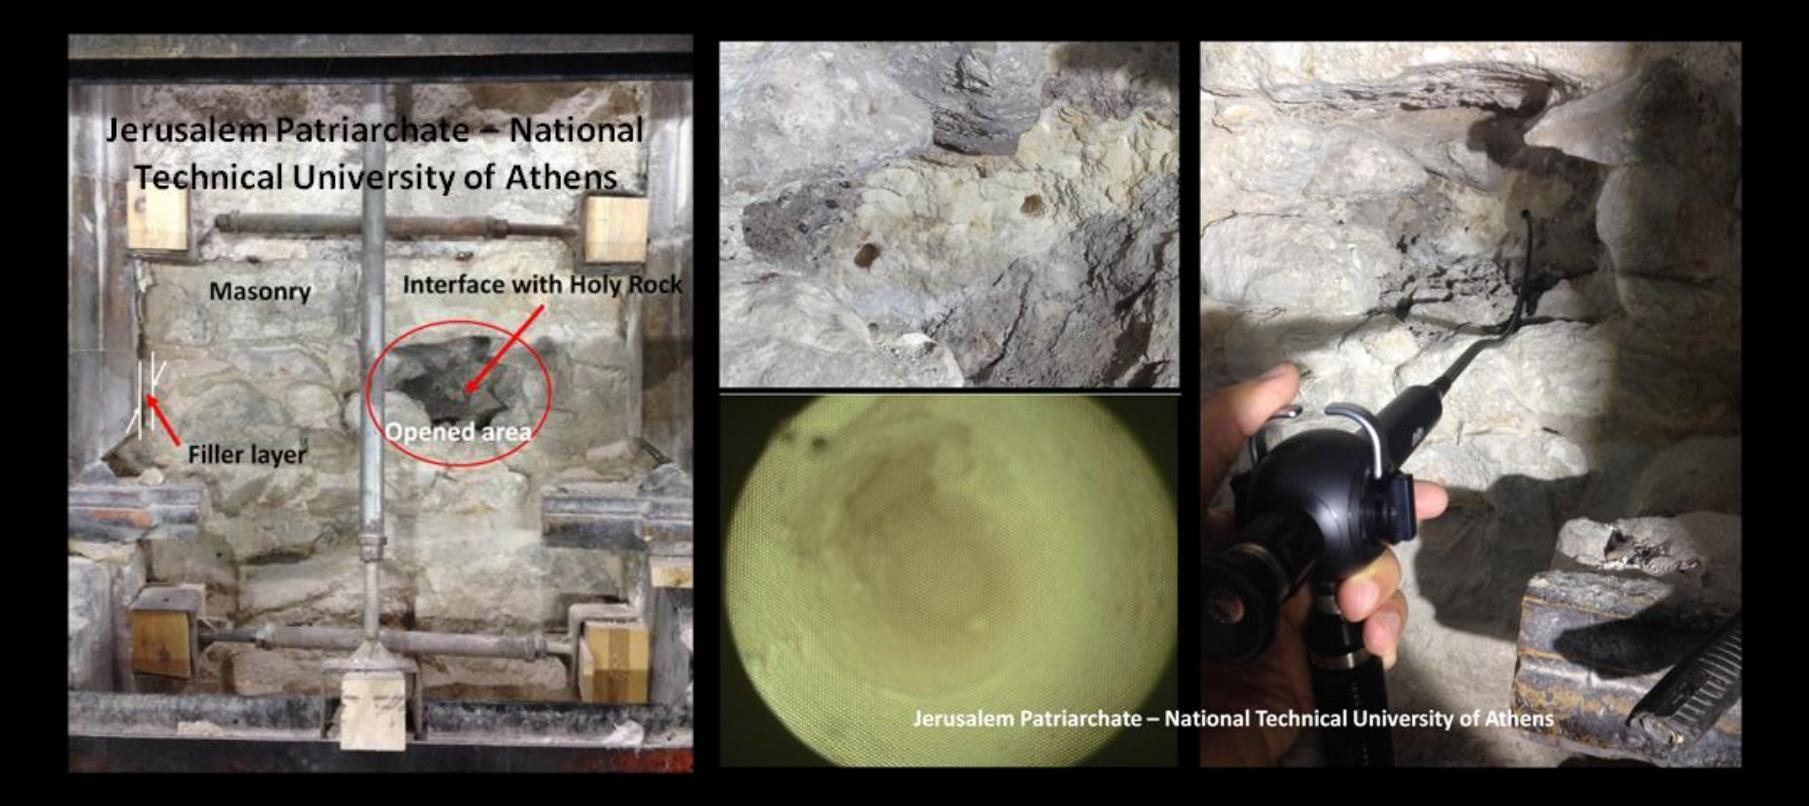
Upper left: The revealed surface of the Holy Rock, in area N3.Right:Endoscopic prospection of the Holy Rock.Lower left: Endoscopy image of the Holy Rock

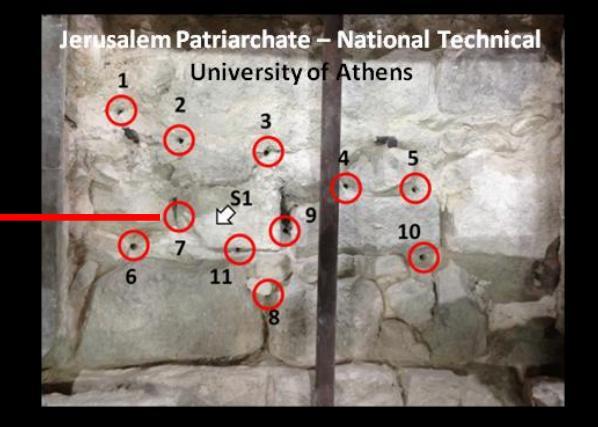
- An **internal cavity** was observed, most possibly corresponding to the back surface of the marble stone at the north side of the interior of the Chapel of the Angel
- The fact that the drilled hole #7 managed to reach the back surface of the interior marble indicates that the stone block labeled S1 could be acting as a filler stone of the 12c. masonry opening.
- Removal of stone block S1, revealed another stone block almost the same size as the opening
- The **dimensions and location of this opening coincide** satisfactorily with the one indicated by **Amico's plans** and as predicted by **GPR** prospection.

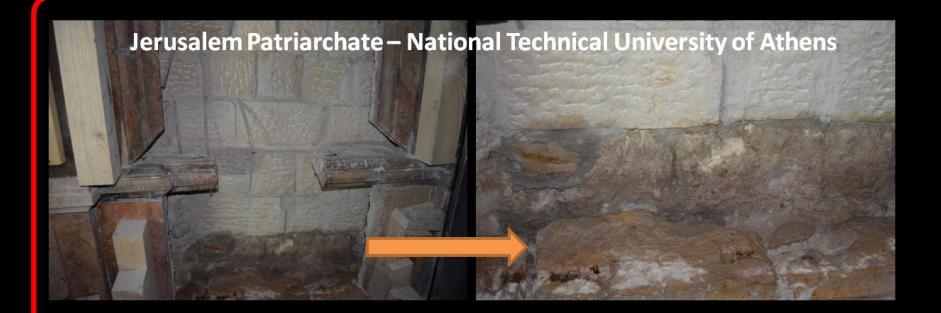
In the masonry comprising the west side of the structure, possible remains of the Crusader's construction phase were identified. Two building stones in the masonry are completely different in terms of surface processing in relation to the surrounding stones and are obviously attributed to a different construction period (A. Moropoulou, E. Korres, et al)

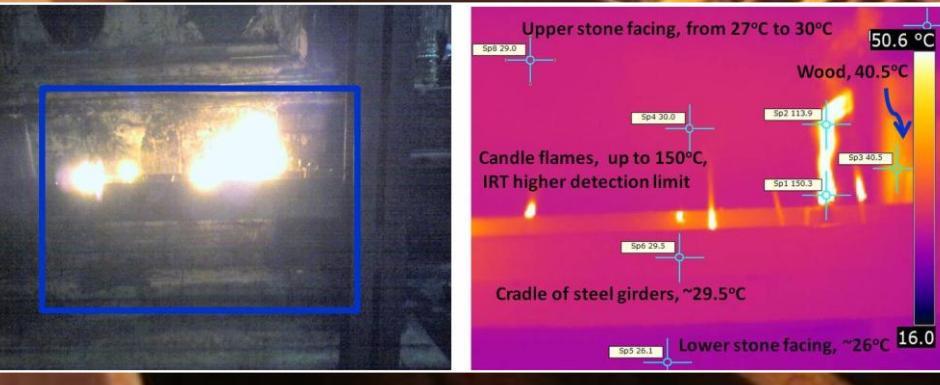
IRT image demonstrating the high temperature variations on the stone facings, due to candles burning

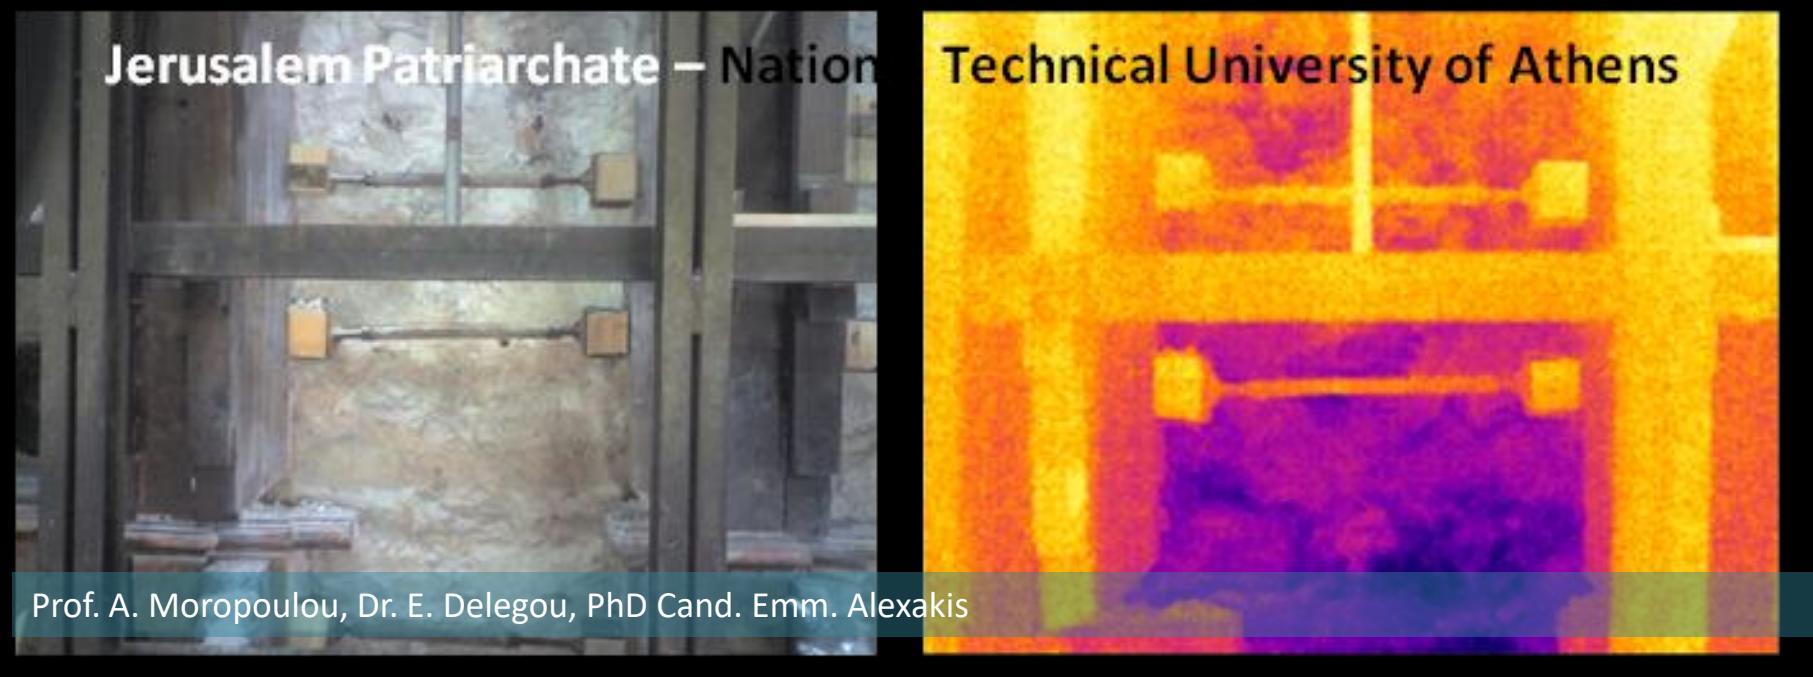
The temperature difference between the lower and the upper part of the masonry is suggested from the thermograph

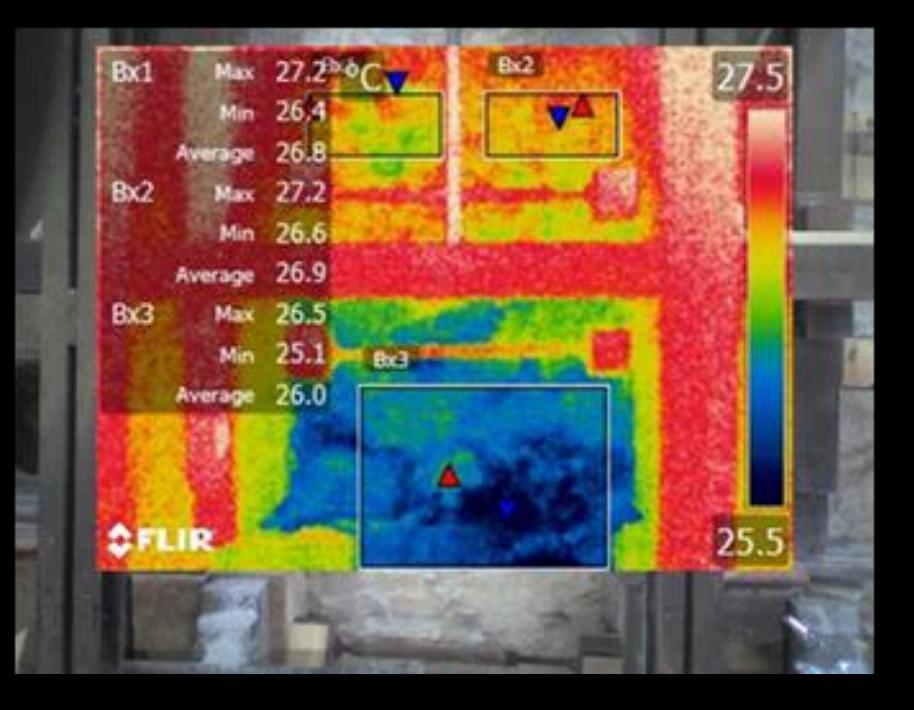
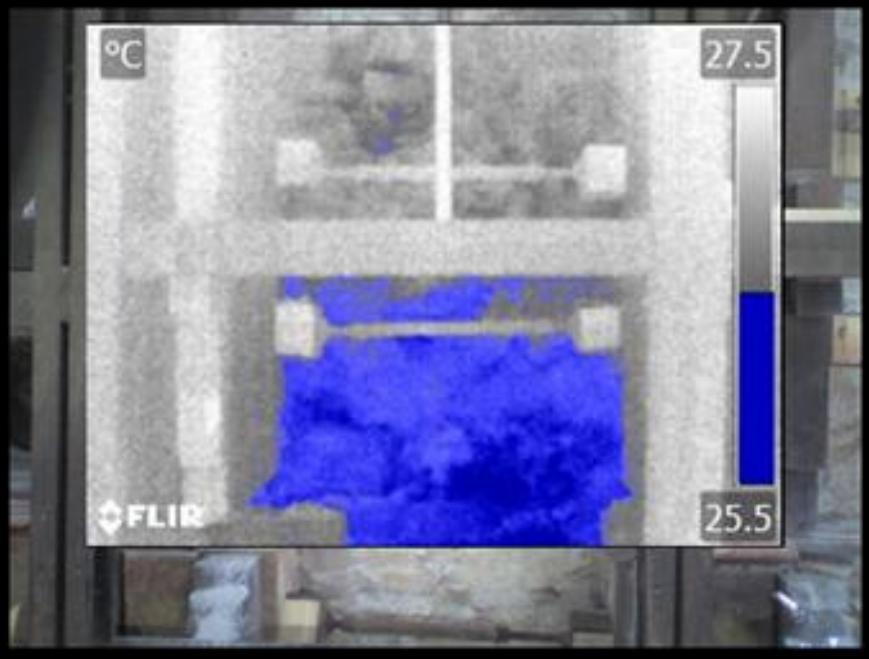
- According to the rectangular boxes 1 and in the upper region, the temperature of the building materials presents small variations with maximum, minimum and average values 27.2, 26.4 and 26.9 °C, respectively
- On the contrary, within the rectangular box 3 at the lower part of the revealed masonry, higher temperature variation is observed where the minimum temperature declines from the average up to 0.9 °C (maximum, minimum and average values 26.5, 25.1 and 26.0 °C, respectively)

- The absence of moist in the higher parts of the masonry suggests that there is moisture transfer from the lower parts of the masonry to the higher ones.
- The lower part of the panel is overwhelmed with moisture (blue color) while the only area colored in blue on the upper part is where the corrupted metallic conjunctions; used by Komnenos to stabilize and reinforce the face stones of the panels, lying.
