9th National Conference of the Hellenic Society of Non Destructive Testing Nov 11th, Athens

NDT prospection in the study, implementation and monitoring of the rehabilitation of the Holy Aedicule of the Holy Sepulchre in Jerusalem within the Scientific integrated governance

Materials & Conservation, Reinforcement and Rehabilitation Interventions in the Holy Aedicule of the Holy Sepulchre

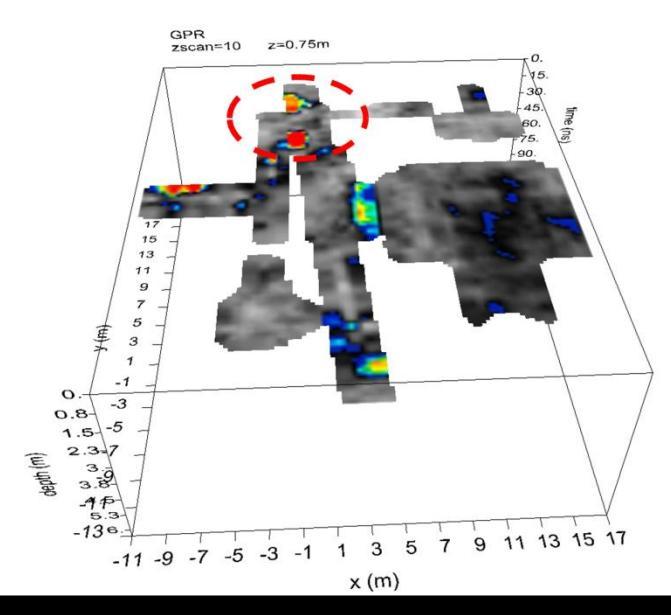
3D GPR Slice (depth = 0.75m) with indication of the targets (red color) identified in the relevant area. These targets correspond to walls M2 and M4

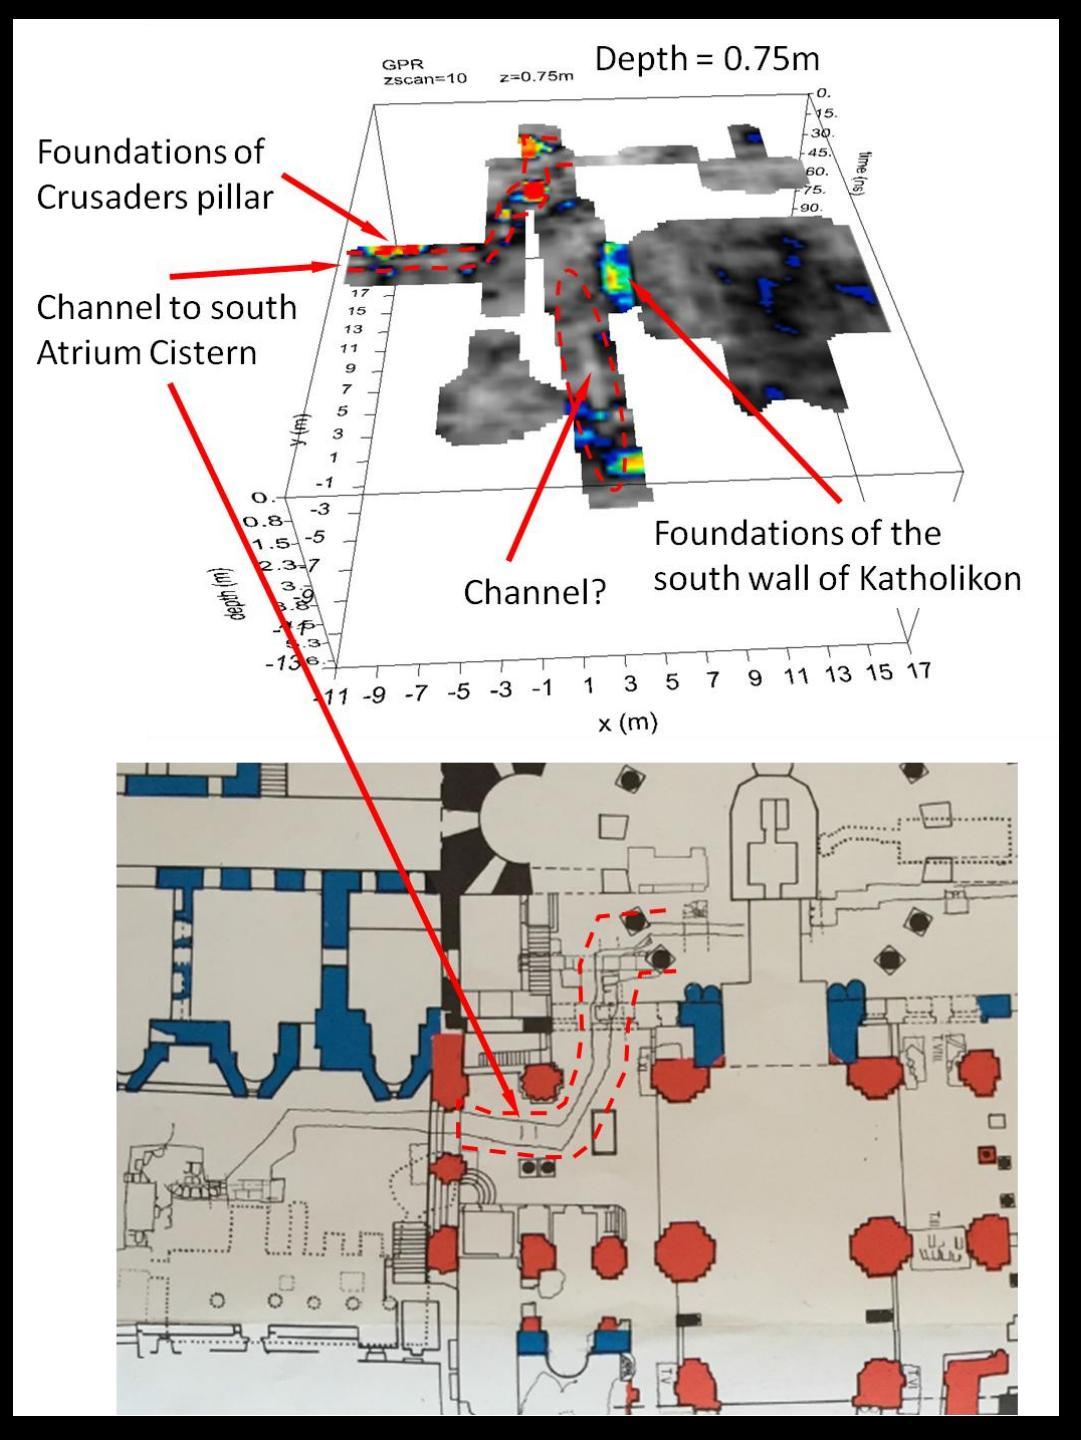
Figure indicates the <u>LOCATION AND</u> EXTENT OF THE CHANNEL THAT RUNS THROUGH THE WESTERN AND MID-PARTS OF AREA F, TOWARDS THE SOUTH ATRIUM.

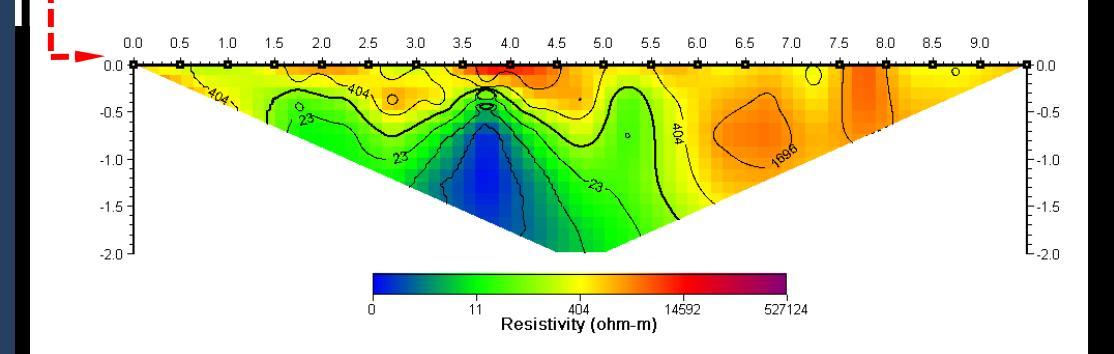
In area CS, there seems to exist a "low resistivity canal shaped area" starting approximately from the base between panels S2 and S1 and with a SE direction, reaching the northern boundary of the Corbo's excavation area.

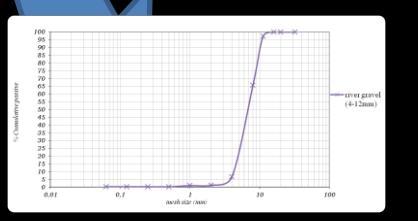
Design of repair filling mortar

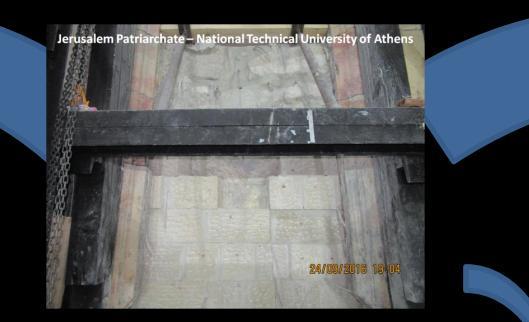
Documentation of the gap between panels & restored masonry
